# UNDERWATER BRIDGE INSPECTION REPORT

STRUCTURE NO. 7054

STURGEON RIVER

DISTRICT 1 - ST. LOUIS COUNTY

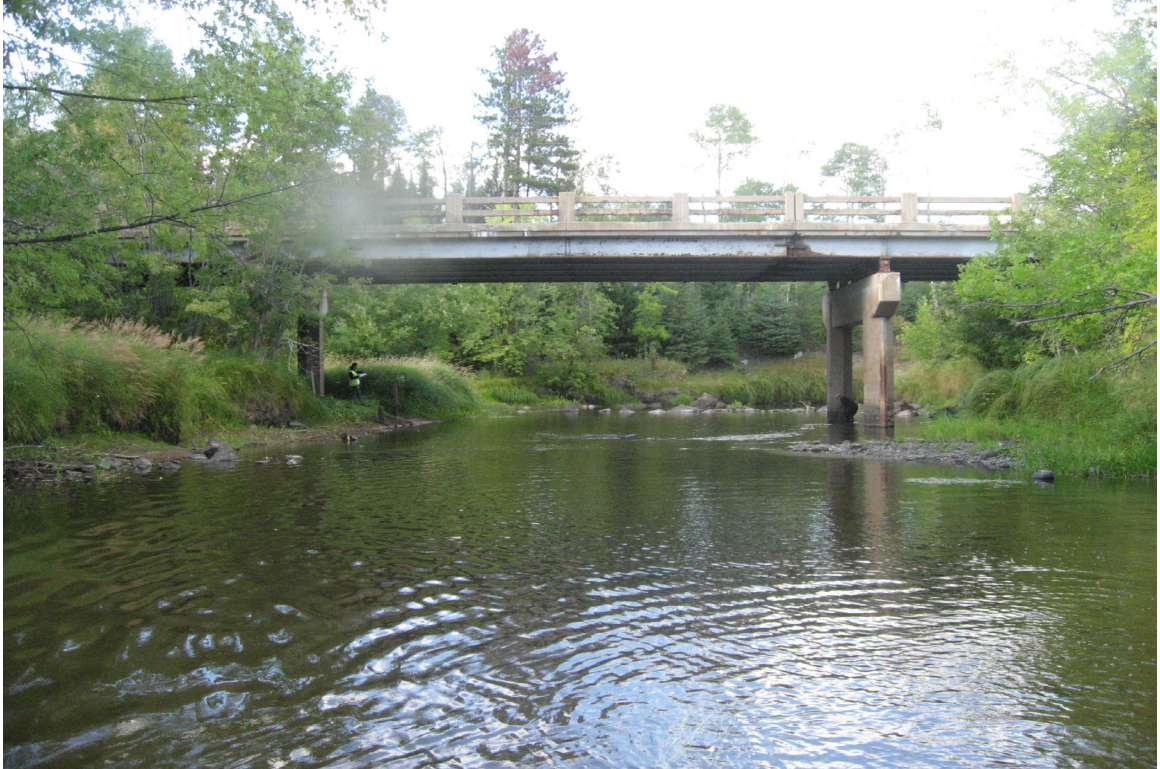
Photograph 1. Overall View of the Structure, Looking North.

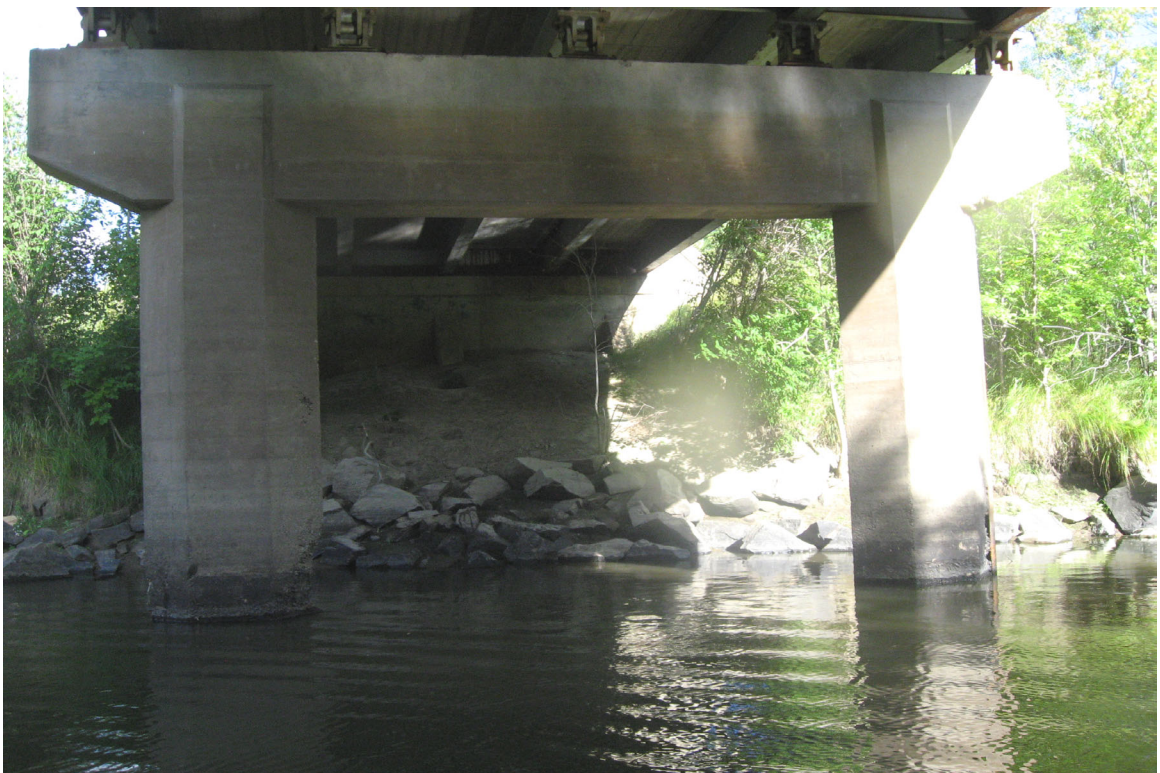
The substructure unit inspected at Bridge No. 7054, Pier 2, was found to be in good to satisfactory condition. The concrete of the pier exhibited light to moderate scaling and several areas of section loss; however, there were no structurally significant defects observed. The channel bottom appeared stable with no evidence of significant scour. A light accumulation of timber debris was observed around both columns of Pier 2.

Photograph 2. View of Pier 2, Looking East.

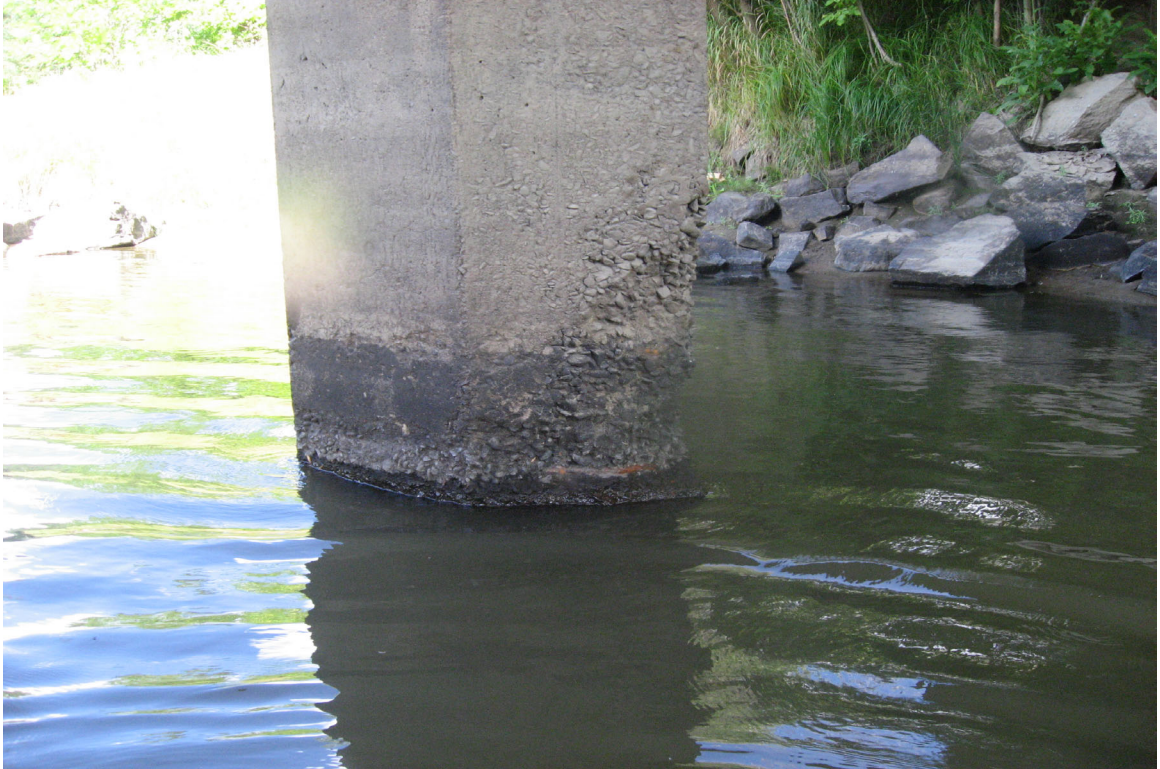
- (B) An area of section loss extending from 2 foot above the waterline to the waterline with a maximum penetration of 4 inches was observed on the upstream face of the downstream column of Pier 2. Corroded reinforcing steel was exposed.

- (D) An area of section loss was observed along the downstream end of the downstream column of Pier 2 from 3 inches above the waterline to 6 inches below the waterline with a maximum penetration of 2 inches. Corroded reinforcing steel was exposed.

Photograph 3. View of the Downstream Column of Pier 2, Looking Northeast.

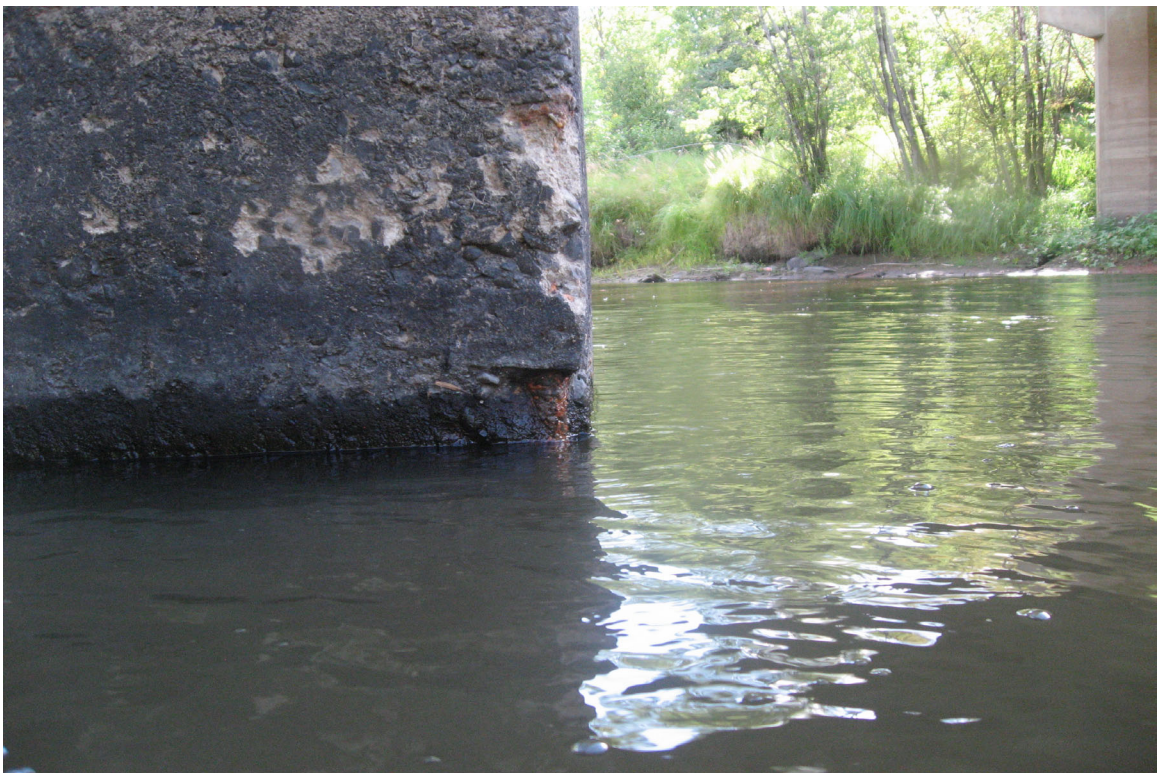
Photograph 4. View of the Downstream Column of Pier 2, Looking Southwest.

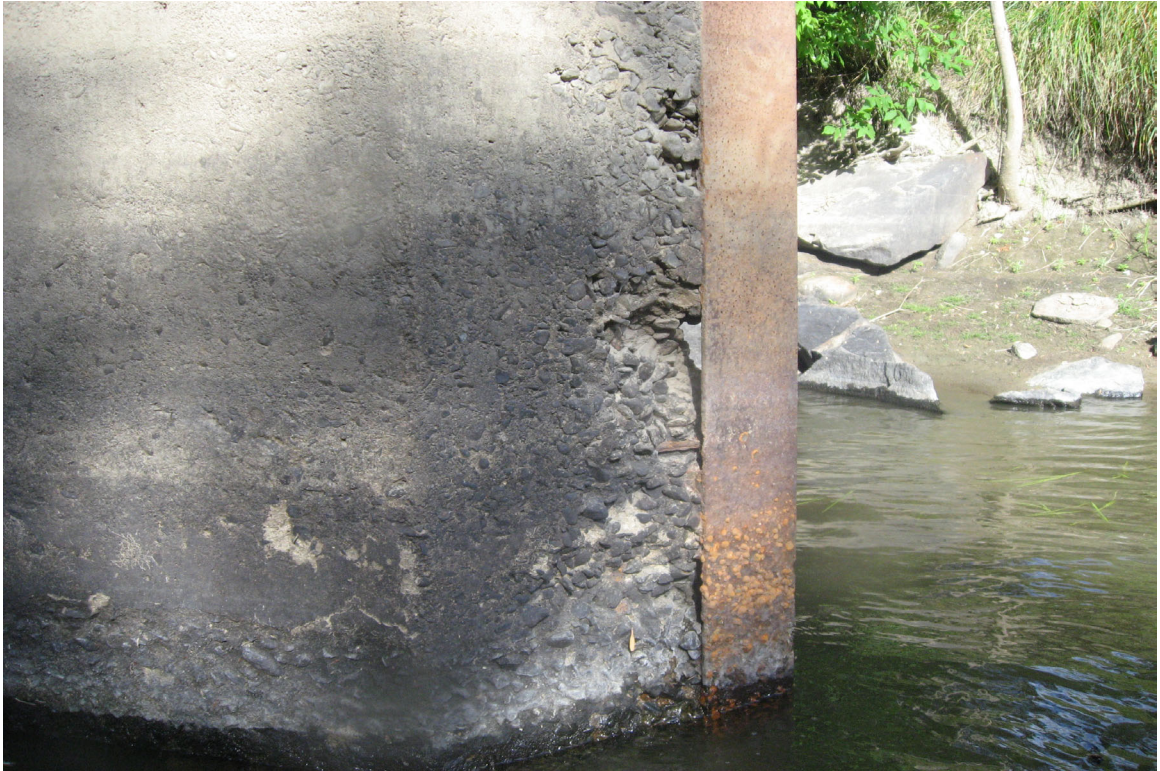
- (A) An area of section loss along the beveled sides of the upstream column, extending from the waterline to 2.5 feet above the waterline with a maximum penetration of 3 inches, was observed on the upstream side of the upstream column of Pier 2. Corroded reinforcing steel was exposed.

Photograph 5. View of the Upstream Column of Pier 2, Looking Northeast.

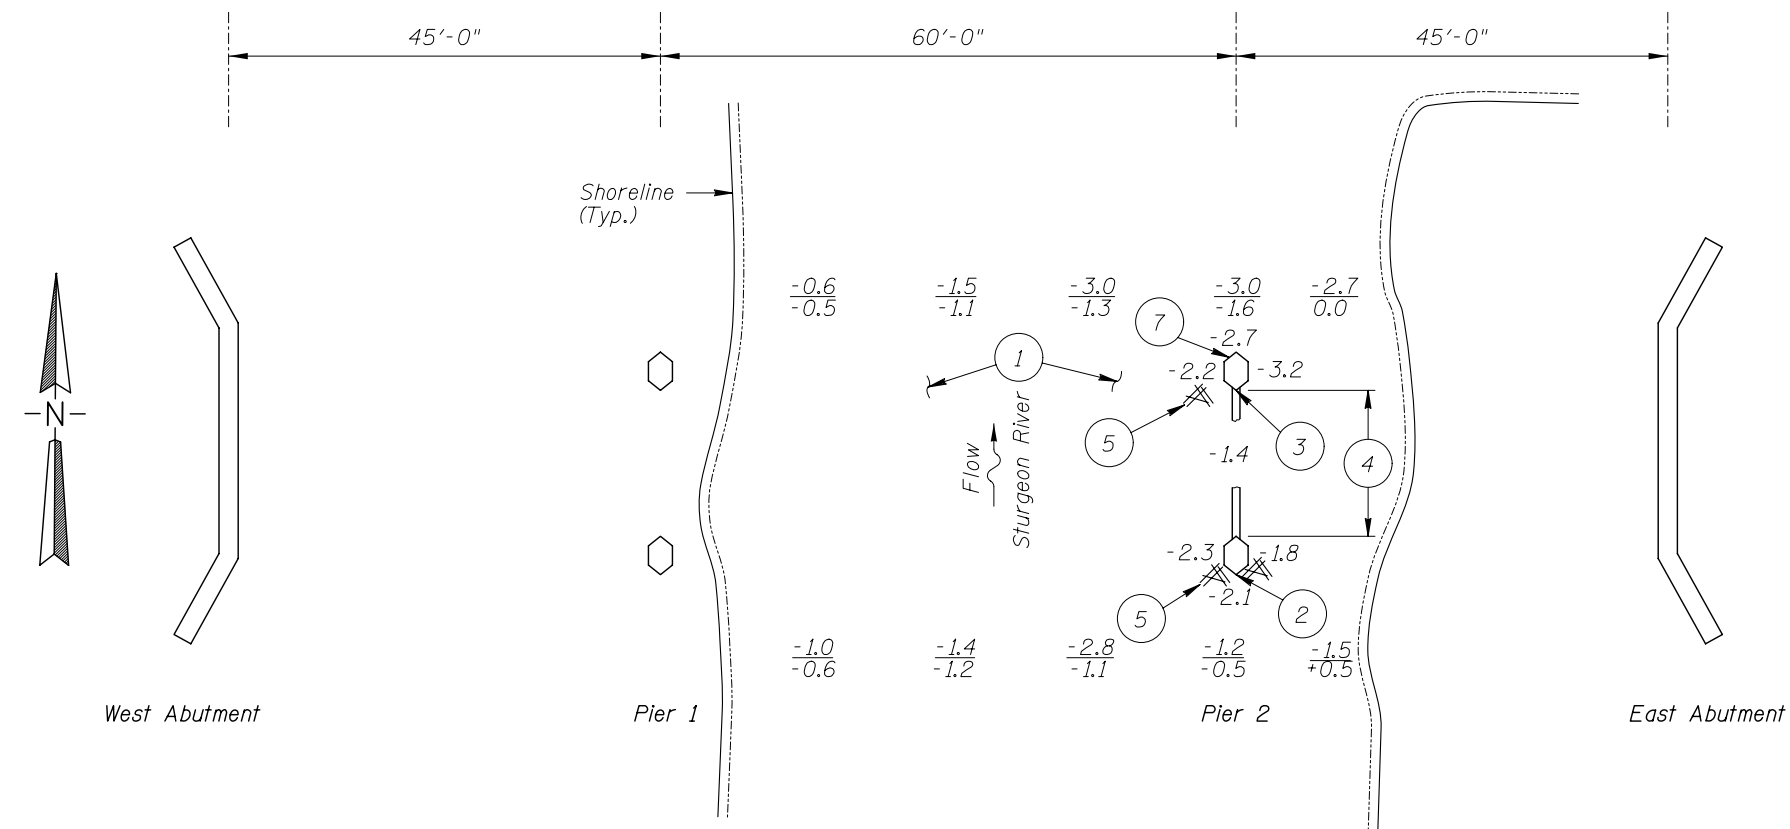
#### INSPECTION AND SOUNDING PLAN

- The channel bottom consisted of silty sand with 0.5 to 1 foot of probe rod penetration.
- An area of section loss along the upstream column bevels was observed from the waterline to 2.5 feet above the waterline with a maximum penetration of 3 inches. Corroded reinforcing steel exposed (20% section loss on vertical bars and 15% section loss on horizontal bars).

- An area of section loss was observed on the upstream face and east and west faces of the downstream column of Pier 2 from 2 feet above the waterline to the waterline with a maximum penetration of 4 inches. Corroded reinforcing steel was exposed (10% section loss).

- The top portion of the horizontal strut was exposed from the upstream column to 4 feet downstream and from the downstream column to 4 feet upstream, and was covered by the channel bottom material along the center of the strut.

- A light accumulation of 3-inch-diameter and smaller timber debris was observed all along Pier 2.
- An area of section loss along the downstream end of the downstream column of Pier 2 was observed from 3 inches above the waterline to 6 inches below the waterline with a maximum penetration of 2 inches. Corroded reinforcing steel was exposed (10% section loss).

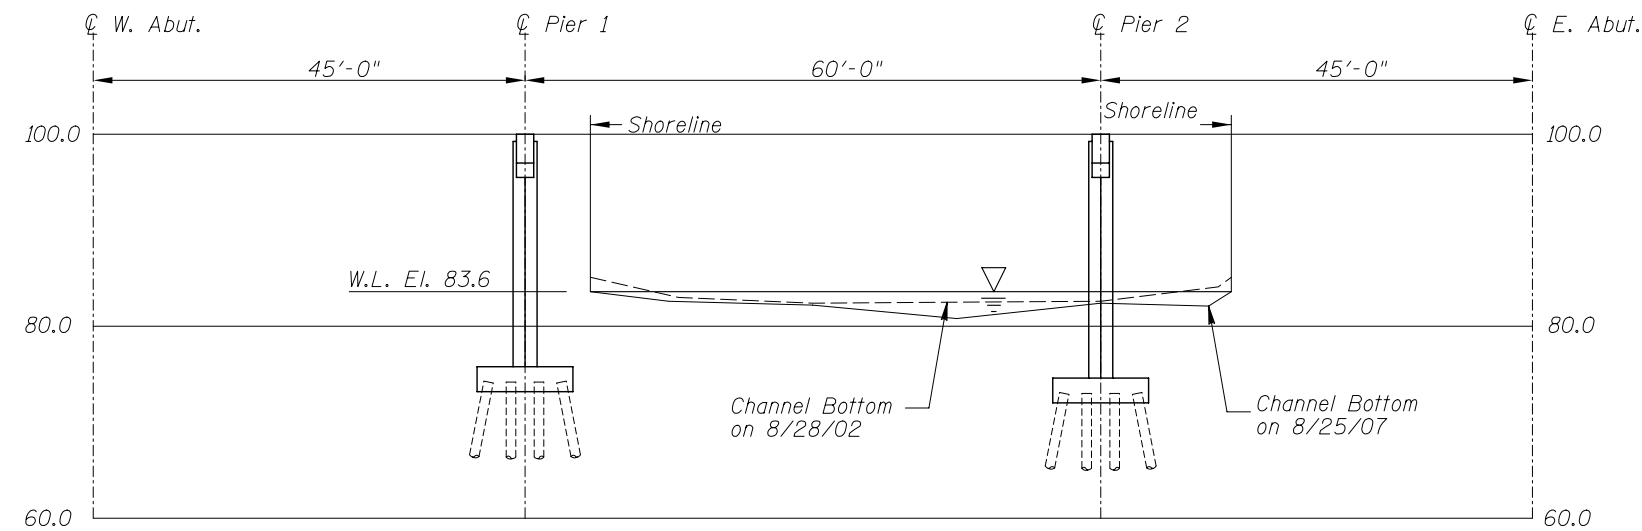
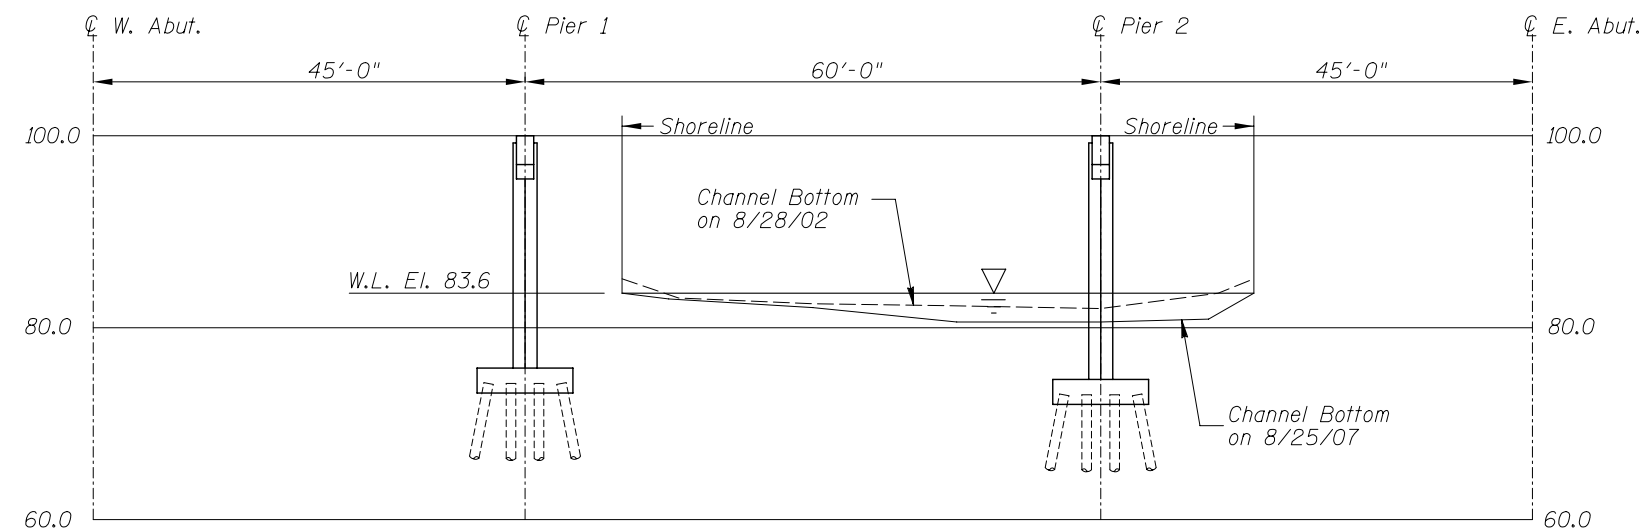
STRUCTURE NO. 7054  
OVER THE STURGEON RIVER  
DISTRICT 1, ST. LOUIS COUNTY  
**UPSTREAM AND DOWNSTREAM  
FASCIA PROFILES**

UPSTREAM FASCIA PROFILE

DOWNSTREAM FASCIA PROFILE
